FORM B - BUILDING

Form Number
1032

Address 2 Berwick Road

Historic Name William & Marcia Nash House

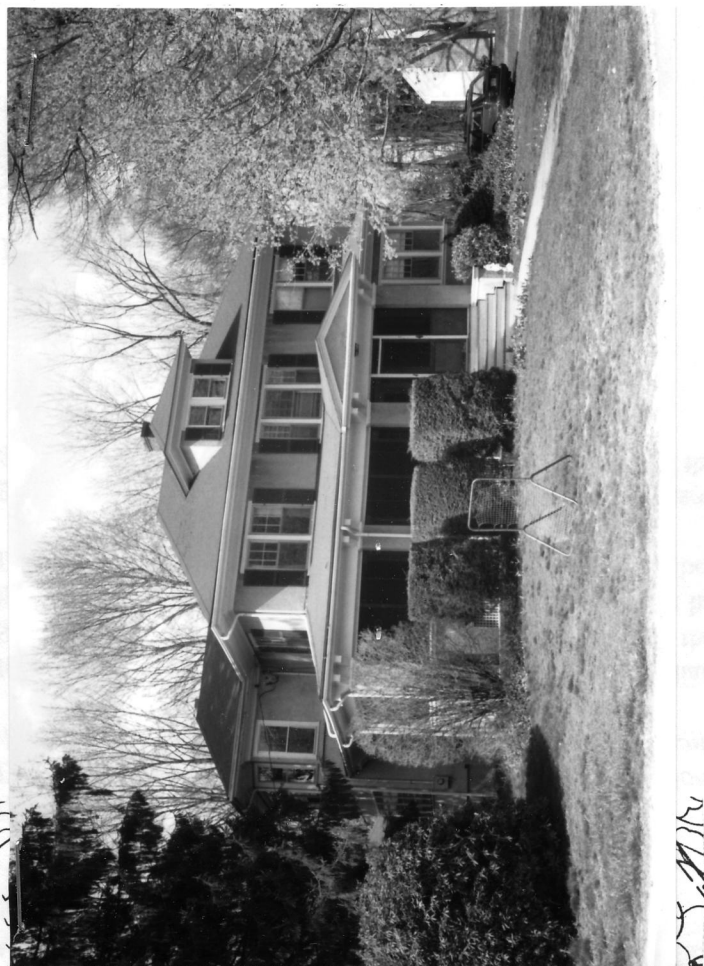
The house at 2 Berwick Road is a 2 1/2-story, stuccoed dwelling that is capped by an asphalt-shingled, hip roof with projecting eaves. The three-bay facade is partially fronted by a single-story porch that extends from the center entrance and wraps around the west elevation, terminating at the two-story hip-roofed wing offset to the northwest. The porch is supported by wide stuccoed posts which are capped by pairs of brackets. A low pediment marks the location of the entrance. Sheltered by the porch, the entrance contains a wooden door with 3 x 4-lights over four recessed panels. The door is framed by partial sidelights. Also sheltered by the porch is a large picture window with multi-light upper band. To the east of the entrance and outside the porch, there is a bay window on the first floor containing three 6/1 windows. The second floor of the facade has a central 6/1 window flanked by 4/1 windows, with a pair of 6/1 windows on either side. Centered on the front roof slope is a hip dormer with two small 6/1 windows.

The rear wing displays two cutaway corners on the second floor with 4/1 windows and a set of four 6/1 windows on the first floor. The east side of the house is four bays deep and displays a variety of window sizes, predominantly 6/1 and 1/1 with a geometric elevated window on the first floor. The back porch on this elevation is supported by plain posts on a stuccoed wall.
